## PRODUCT INFORMATION SHEET - V8 CYLINDER HEAD GASKETS

### Part Numbers Applicable To:

UE31004 - UT12890PD - 07V103147

All models from 1959 to 2004 with a V8 engine – see Appendix A

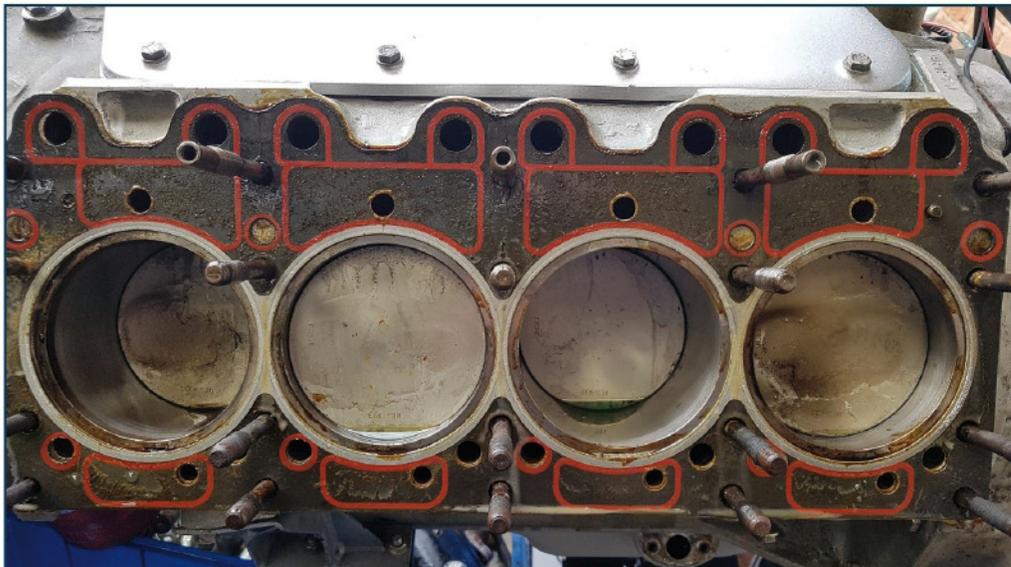
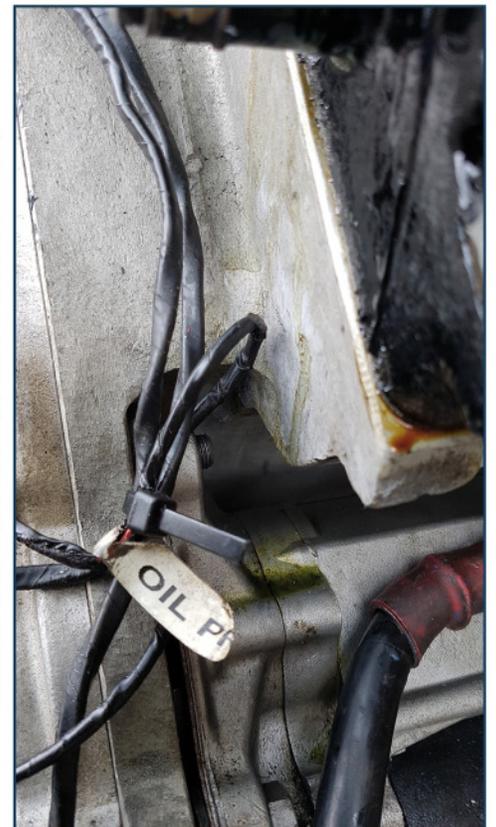
Since March 2019 we have become aware that some engines, having had the head gaskets replaced, have leaked externally and/or internally. We believe that it is the head gasket itself that is the cause of these failures. As part of our investigations into these failures we have been measuring batches of gaskets and recording the dimensions. This has led us to conclude that the most likely cause of the gasket failure is that the difference in height between the steel firing ring (the section around the top of the cylinder liner) and the composite material (that forms the principal part of the gasket) exceeds acceptable tolerances. Allied to this is a suspicion that the red silicone beading has not been correctly applied to the gasket.

Images show examples of both internal and external leaks.

We have regrettably removed these gaskets from sale as we are unable to offer any warranty on them.

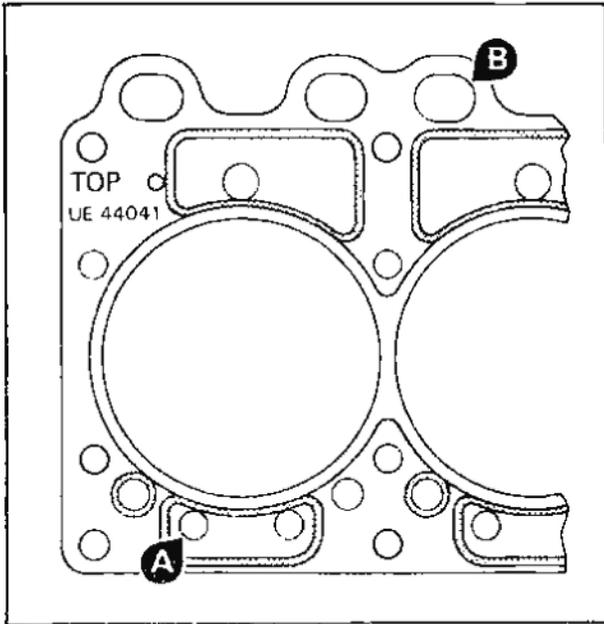
Fig 1 Early Bentley Mulsanne Turbo Gasket (UE 44041)

- A Two coolant passage holes
- B Size of push rod hole

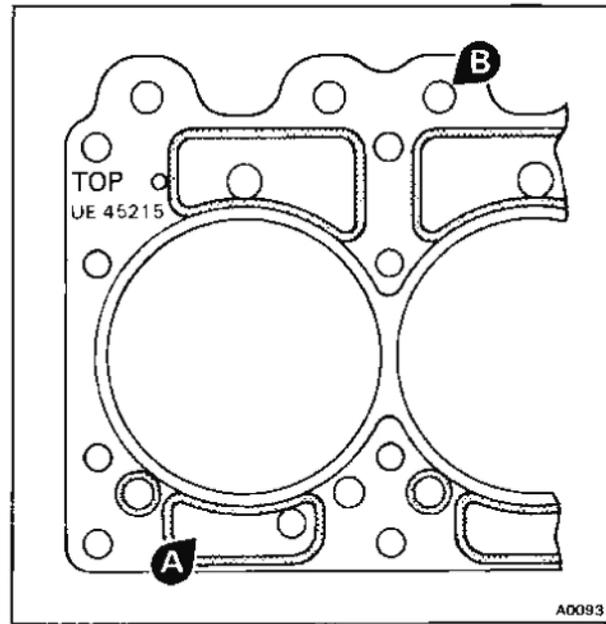
Fig 3 New Gasket Now Used on ALL Engines (UE 45215)

The new cylinder head gasket is similar to that used previously on the Bentley Mulsanne Turbo engine. However, changes have been made to the push rod hole size and one of the coolant hole passages has been deleted (see figs.1 and 3).

- A One hole has been deleted
- B Push rod hole decreased in size

The latest gasket (UE 45215) can be used for ALL Bentley Mulsanne Turbo engines, but MUST NOT be used on normally aspirated engines prior to vehicle identification numbers listed above. UE 31004 must be used on all these earlier engines.
