## PRODUCT INFORMATION SHEET - V8 CYLINDER HEAD GASKETS

### Part Numbers Applicable To:

UE31004 - UT12890PD - 07V103147

All models from 1959 to 2004 with a V8 engine – see Appendix A

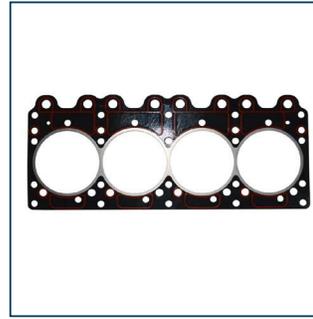
07V103147

In 2015 customers started to report failures of the OE (Original Equipment/ Genuine Bentley) cylinder head gaskets (07V103147 – which are stamped with the previous part number UT12890PD) which we felt were caused by blistering of the red bead on the gasket which allowed coolant to bypass the gasket.

In 2019 further failures were reported of the OE cylinder head gaskets (07V103147) with engines which were leaking immediately after the head gaskets had been replaced.

All head gaskets (07V103147) were inspected by the manufacturer. Those deemed to be within specification were returned to Bentley Motors who made them available for sale **but they still failed.**

**Therefore, we strongly advised against fitting the OE gasket (07V103147) and recommended our replacement aftermarket gasket UE31004P.**

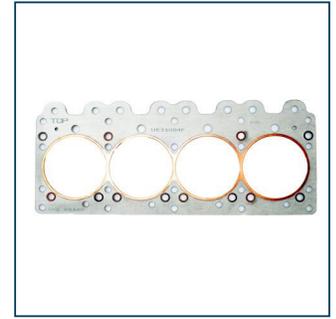
C) Previous failures caused by insufficient or inadequate beading on 07V103147 have been overcome by not using this type of beading on UE31004P.

At the time of writing (Sept '24) we have sold over 1800 of our re-designed UE31004P gaskets and experienced no failures whatsoever.
